A PYROTECHNIC -ACTIVATED CALORIMETER FOR FLIGHT RESEARCH

AT LUNAR RETURN VELOCITY

By Don D. Davis, Jr., and Clotaire Wood

Presented at the International Colloquium on the Utilization of Pyrotechnic and Explosive Elements in Space Systems

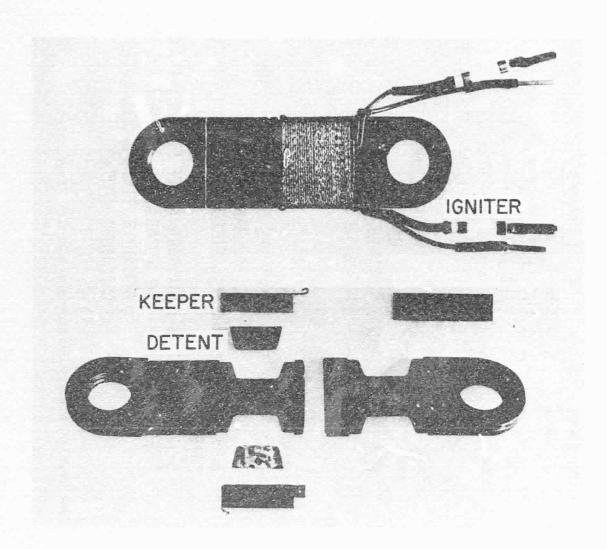
Figure 5.- Photographs of assembled heat-shield ejection link and parts.

The ejection link can be seen bolted to quadrant C in figure 4. Figure 5 shows how the link was built. The parts of the link are shown in the lower photograph. The right end of the link was made with a slot and the left end had a mating tongue. When these parts were mated, they were locked by the two wedge-shaped detents which were positioned by the keepers. After the keepers were installed, this assembly was tension wrapped with the

previously described stranded exothermic fuse wire. When this wire was locally heated to the melting point by an electrical current, an exothermic alloying reaction took place and the remaining wire rapidly disintegrated. This action freed the detents and allowed the links to separate under the action of the springs in quadrants A and C (fig. 4). The impulse from these springs was sufficient to rapidly eject quadrants A and C from the reentry package. Meanwhile, as soon as the link ends had separated, quadrants B and D were free to move and they were rapidly ejected under the action of their springs.
